**DEPARTMENT OF TRANSPORTATION****DIVISION OF ENGINEERING SERVICES**

Quality Assurance and Source Inspection

Contract #: 04-0120F4Cty: SF/ALA Rte: 80 PM: 13.2/13.9File #: 69.28**WELDING INSPECTION REPORT****Resident Engineer:**Pursell, Gary**Address:** 333 Burma Road**City:** Oakland, CA 94607**Report No:** WIR-013844**Date Inspected:** 05-May-2010**Project Name:** SAS Superstructure**OSM Arrival Time:** 1900**Prime Contractor:** American Bridge/Fluor Enterprises, a JV**OSM Departure Time:** 700**Contractor:** Zhenhua Port Machinery Company, Ltd (ZPMC), Changxing Island **Location:** Shanghai, China**CWI Name:** See Below**CWI Present:** Yes No**Inspected CWI report:** Yes No N/A**Rod Oven in Use:** Yes No N/A**Electrode to specification:** Yes No N/A**Weld Procedures Followed:** Yes No N/A**Qualified Welders:** Yes No N/A**Verified Joint Fit-up:** Yes No N/A**Approved Drawings:** Yes No N/A**Approved WPS:** Yes No N/A**Delayed / Cancelled:** Yes No N/A**Bridge No:** 34-0006**Component:** OBG**Summary of Items Observed:**

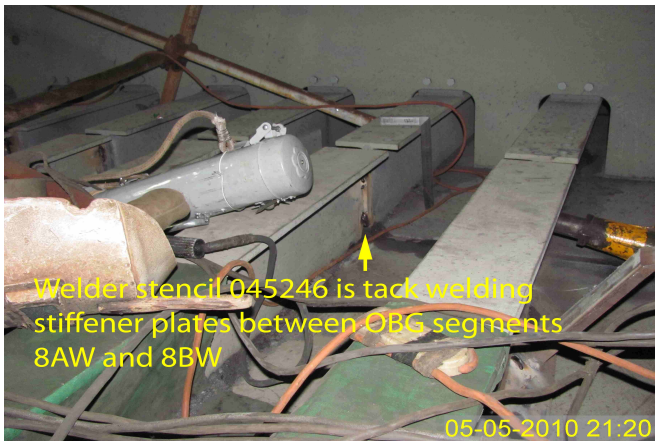
This QA Inspector observed ZPMC welder Mr. Tian Zhaoquan, stencil 045246 is using shielded metal arc welding procedure WPS-B-P-2213-B-U2-FCM-1 to make 3G (vertical) position shielded metal arc tack welds on stiffener plates between OBG segments 8AW and 8BW counterweight side plates. This QA Inspector observed Mr. Tian Zhaoquan has a welding current of approximately 160 amps and Mr. Tian Zhaoquan appears to be certified to make this weld. This QA Inspector observed the welding electrodes are being stored in a heated portable electrode storage oven and the base material appears to have been preheated with an electrical heating element located on the interior of the OBG segments. Items observed on this date appeared to generally comply with applicable contract documents. See the photograph below for additional information.
